# **An Assessment of Streambank Stabilization and Riparian Restoration Efforts at Buffalo National River, Arkansas**

**Prepared By:**  
**David N. Mott, Hydrologist**  
**and**  
**Tony Collins, Hydrologic Technician**  
**National Park Service**  
**Buffalo National River**

February, 2002

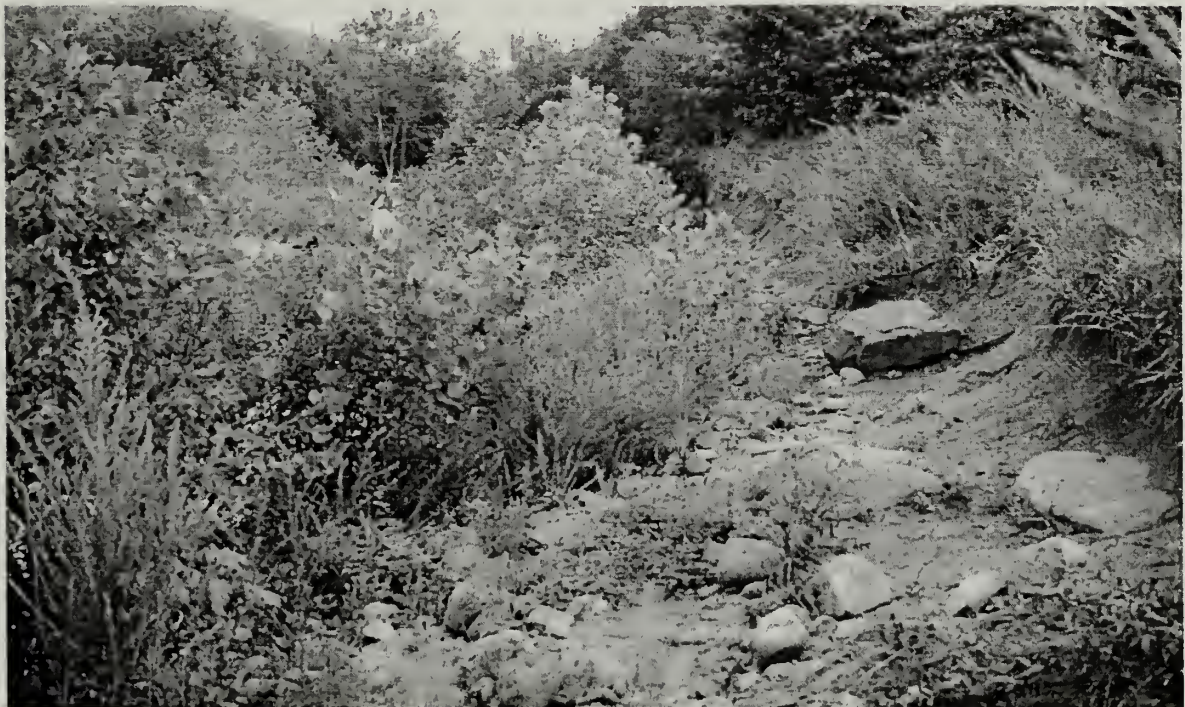
**Photo 2: Lower half of the Wilderness Boundary Site (2000).**

A cedar revetment was not constructed at this site because the cobble lag at the toe of the bank would make driving of anchors very difficult. The riparian area was already beginning to revegetate as well and planting of saplings and seedlings has already been done in this area. Monitoring work indicates that the bank has receded little in the past nine years and vegetation is taking hold at the toe of the bank, which also indicates stability. Actions to cut the bank back or use heavy equipment on the top of the bank would probably have done more harm than good due to damaging the woody vegetation trying to take hold on this bank. Cobble bars are also beginning to form in the channel near the base of the bank and are revegetating. The most important factor leading to stabilization of this bank is that the channel disturbance ceased. Park staff back-sloped a 50 foot portion of this bank in the late 1980s and drove numerous willow stakes into the back-sloped region. The willow stakes died, as can be seen in Photo 1. Several other willow staking attempts were made at various locations throughout the length of the river and at various elevations relative to the channel. In our experience willow staking does not work here because the stakes do not seem to be able to tolerate the radical changes in stage experienced by the river over the course of a given growing season. However, we have found a method to use willows for bioengineering which is discussed later in the willow transplanting section.

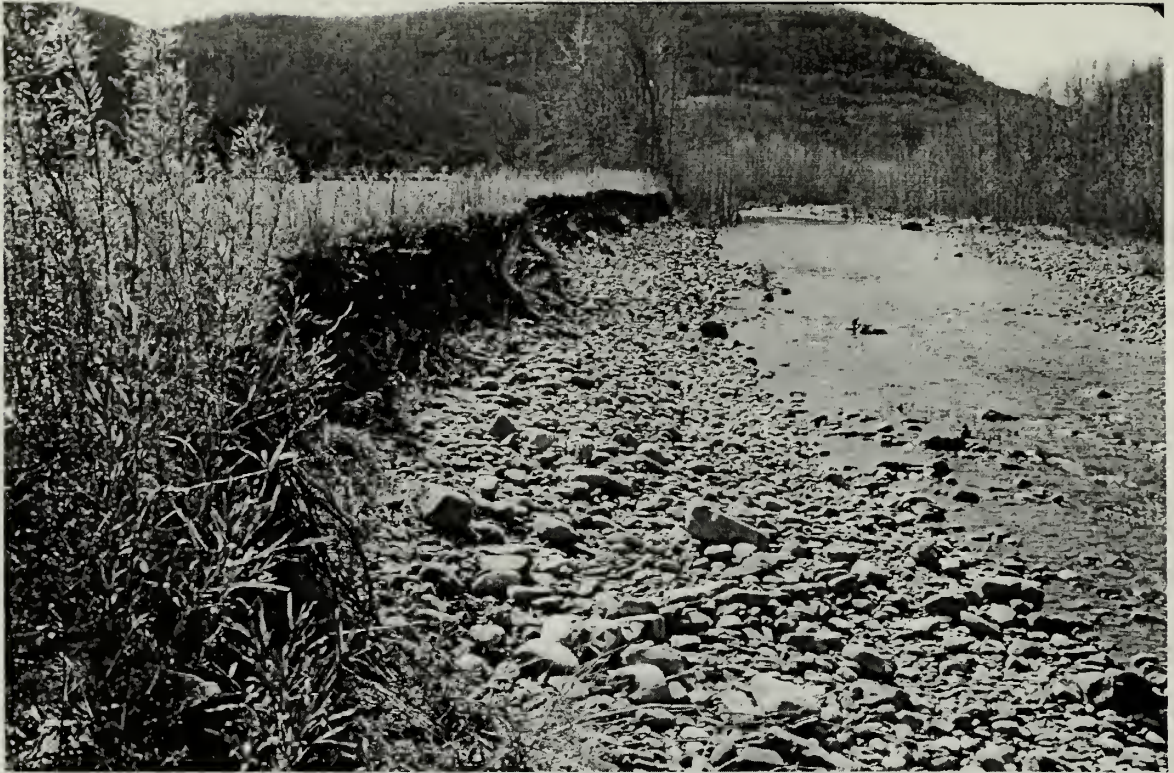
**Photo 3: View upstream of Luallen Site (1994).**

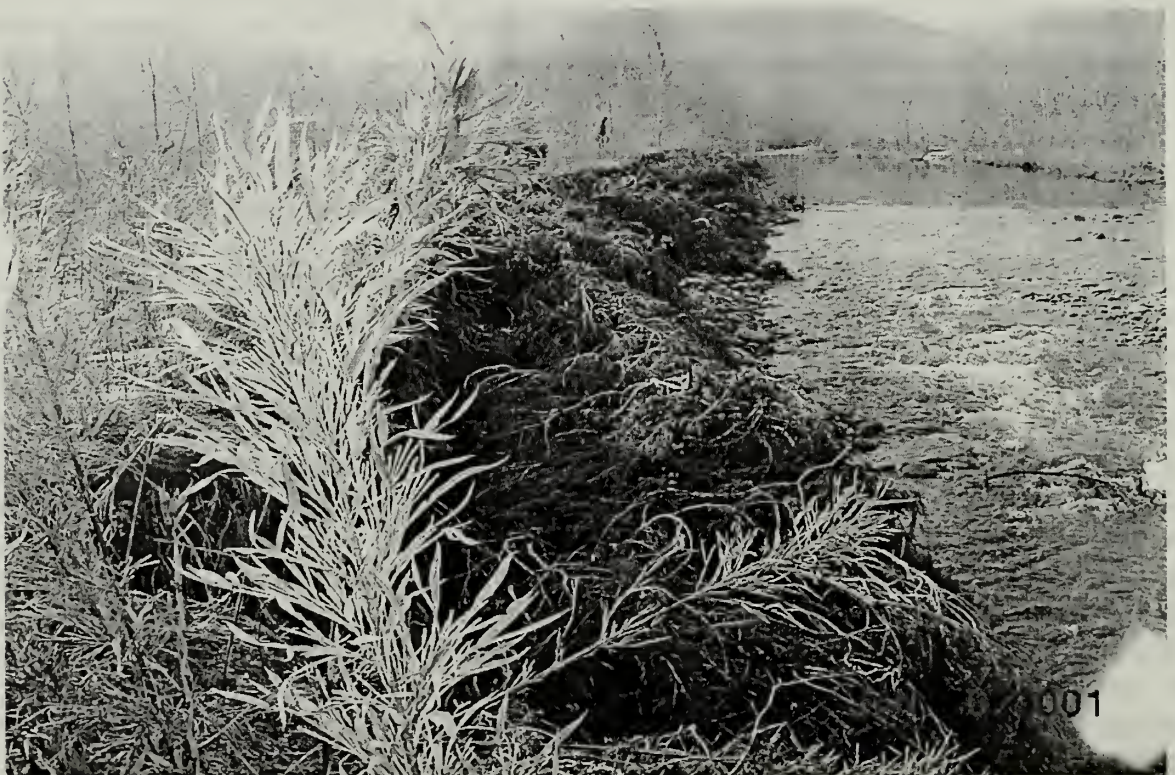
**Photo 4: View upstream of Luallen Site (2001).**

**Overall Summary** – The revetment and experimental willow staking efforts here have partially failed. It was discovered in part as a result of this project, that willow transplanting rather than willow staking was more successful. The lower portion of the bank has eroded an additional 25 feet since 1994. The riparian corridor has a good growth of mixed hardwood, but has been cut back to only 75 feet in width in some places. The channel here does appear to be attempting to stabilize. The toe of the upstream 250 feet of the site has numerous sycamore trees emerging from it. The lower 200 feet of the revetment was rebuilt in December of 2000 (as can be seen in photo 4) and willows were transplanted rather than staked. The dominant reason for failure, in the lower 200 feet, resulted from a combination of factors. The extremely high magnitude flash floods that come out of the Boston Mountains radically scour the bank. Also, the overwidening and other geomorphic alterations caused by the gravel mining have affected pool – riffle spacing, sediment transport, and flood plain interactions, among others. One result of this is acres of even-aged willow propagation within the channel opposite the erosion bank. The willows are continually encroaching on the channel and forcing flow against the revetment. Our latest strategy combines the replacement of the cedar revetment with whole willow transplanting, or moving willows roots and all, from the river left edge of channel to the river right edge of channel in front of the revetment. In essence we are fighting willows with willows (see willow section for further discussion). While we have had good success with willow transplanting at other sites, this site represents additional challenges and we can not yet say if the transplanted willows will be able to offset the encroachment of volunteer willows. Because of the radical alteration of this ¾ mile long reach where the gravel mining took place, it may be appropriate to consider using natural channel design techniques which restore bank-full fluvial geomorphic channel parameters if this site continues to show less than desirable response to our current treatments. We will continue to monitor this site and repair if necessary.

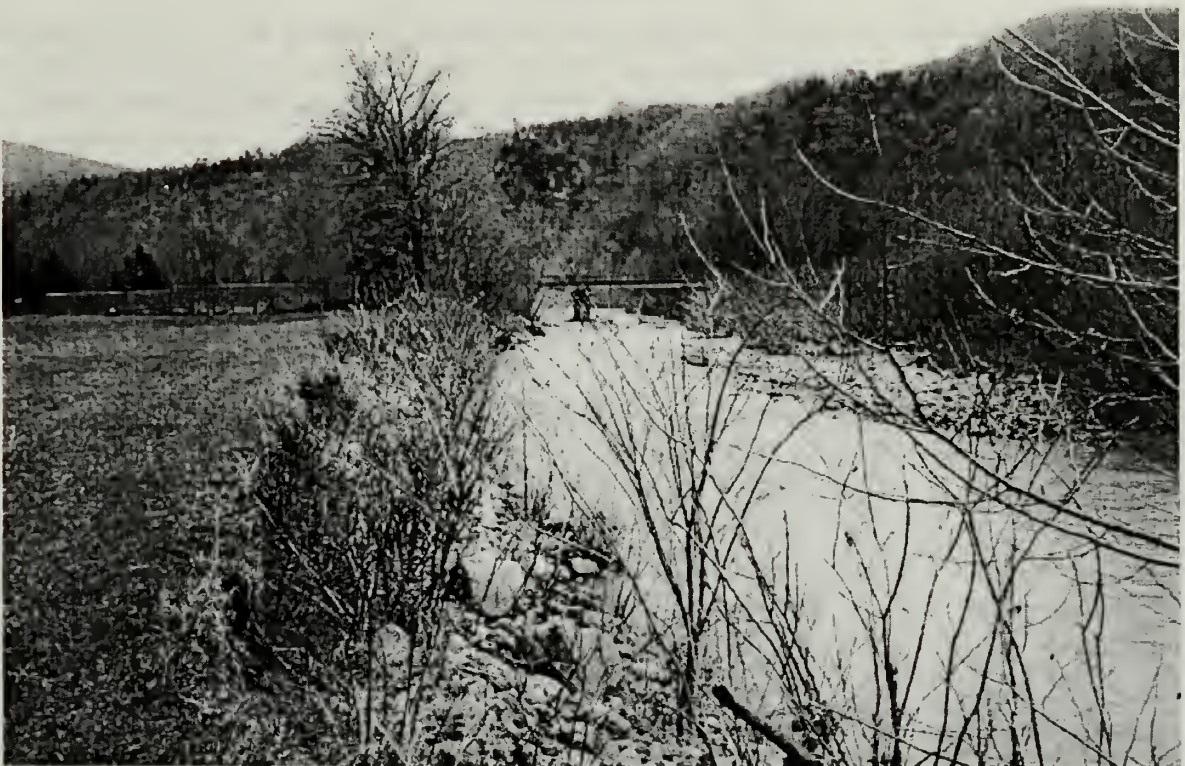
This site is located just above the confluence of Beech Creek and the Buffalo River. This section of Beech Creek channel was reamed out with a bulldozer as recently as 1989. Much of the material pushed out of the channel was dozed up onto the bank to "armor it" against floodwaters. While the naked part of the bank was somewhat stabilized by this process, the downstream forested buffer was being destroyed. There was a well-vegetated floodplain opposite the treated bank at a lower elevation. The bank grades from sand at the top through, gravel, cobble and small boulders near the base. Bedrock is visible in the channel and a point bar is forming on the opposite side of the channel. A highway bridge about 600 feet below the lower end of reach should limit the amount of lateral migration this site can experience. The eroding bank, which is approximately 9 feet high and 228 feet long, is being propagated into the downstream buffer area by scour below the root zone. This leads to trees toppling off the top of the undercut bank. The channel straightening and reduction in roughness brought on by the bank armoring work worsen the scour. Both straightening and reduction in roughness lead to higher velocity floodwaters impinging on the downstream portion of the bank. The toe of the treated site is now stable, but reduction in hydraulic roughness from bank armoring has caused the riparian buffer to be eroded further downstream of the site. Based on measurements taken from 1972 and 1992 aerial photos, the eroding bank has grown about 100 feet in length over the 20-year period as the downstream end of the buffer continues to erode.

Photo 5: View downstream of Beech Creek Site (1994).

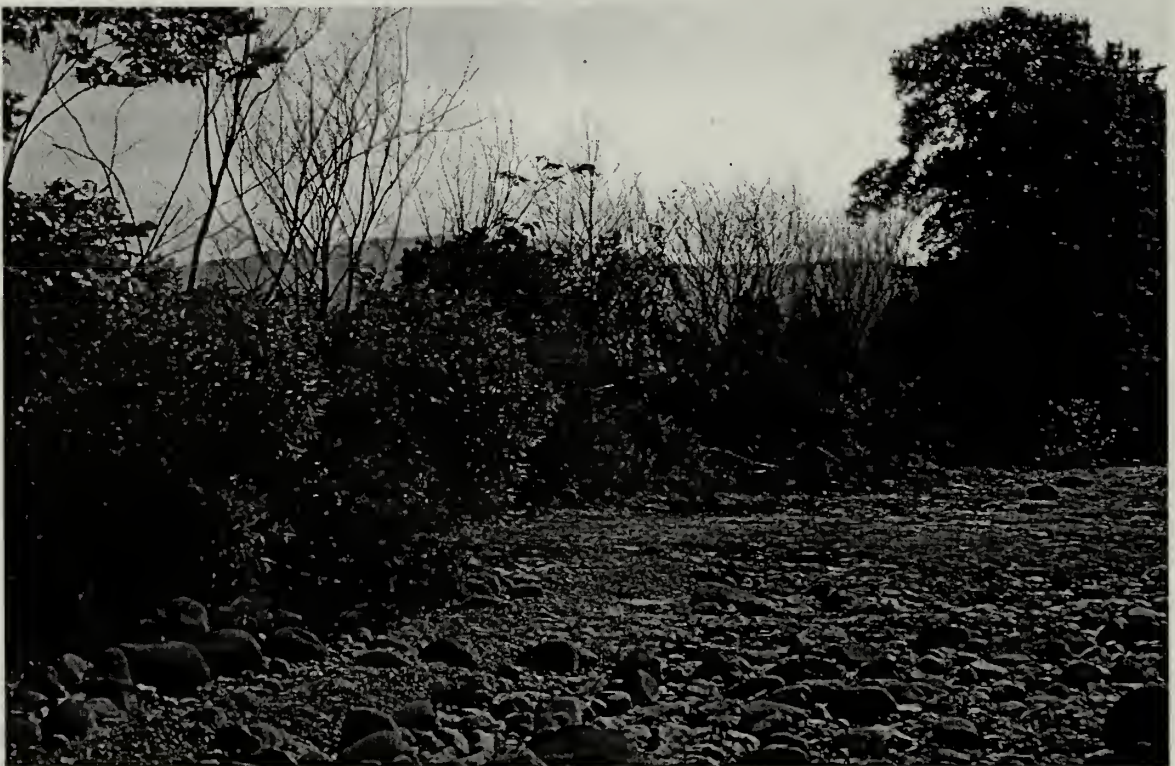
Overall Summary – Efforts here have been 100% successful. This bank has stabilized and is beginning to revegetate. There is no active erosion at this site or in the downstream buffer. There are 1 to 2 inch sycamore, sweet gum, walnut trees and sumac bushes populating the bank and a variety of dense annual vegetation. There are willows at the toe of the bank on the upstream end moving the water away from the toe of the bank. The bank is no longer eroding and is holding a one to one slope. There is heavy elk use here and that could be a concern in the future.

**Photo 7: View from upstream of Beech Creek Site (2001).**

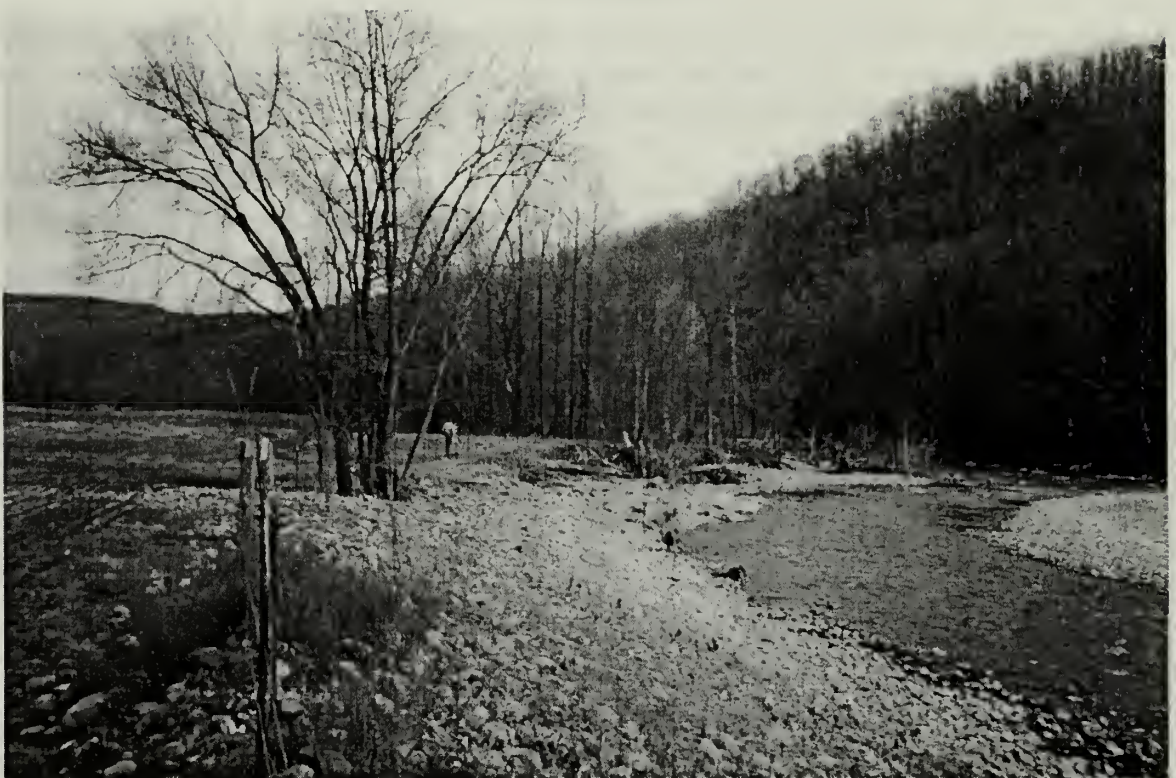
This site is located on the main channel of the Buffalo River inside the Boxley Valley National Historic District. This section of the main channel of the Buffalo River was reamed out with a bulldozer as recently as 1989. Much of the material was dozed up onto the bank to “armor it” against floodwaters. While this did protect the bank for a short time, the downstream end of the bank became exposed and a vertical face was beginning to erode. There is a well vegetated point bar forming between the main channel across from the bank and an overflow channel on river right. The bank grades from a sandy clay loam through gravel, cobble and small boulders near the base. The bank is 9 feet high and more than 450 feet long and was being propagated into the downstream buffer area by scour below the root zone.

**Photo 9: Downstream view of Ferguson bank (1993).**

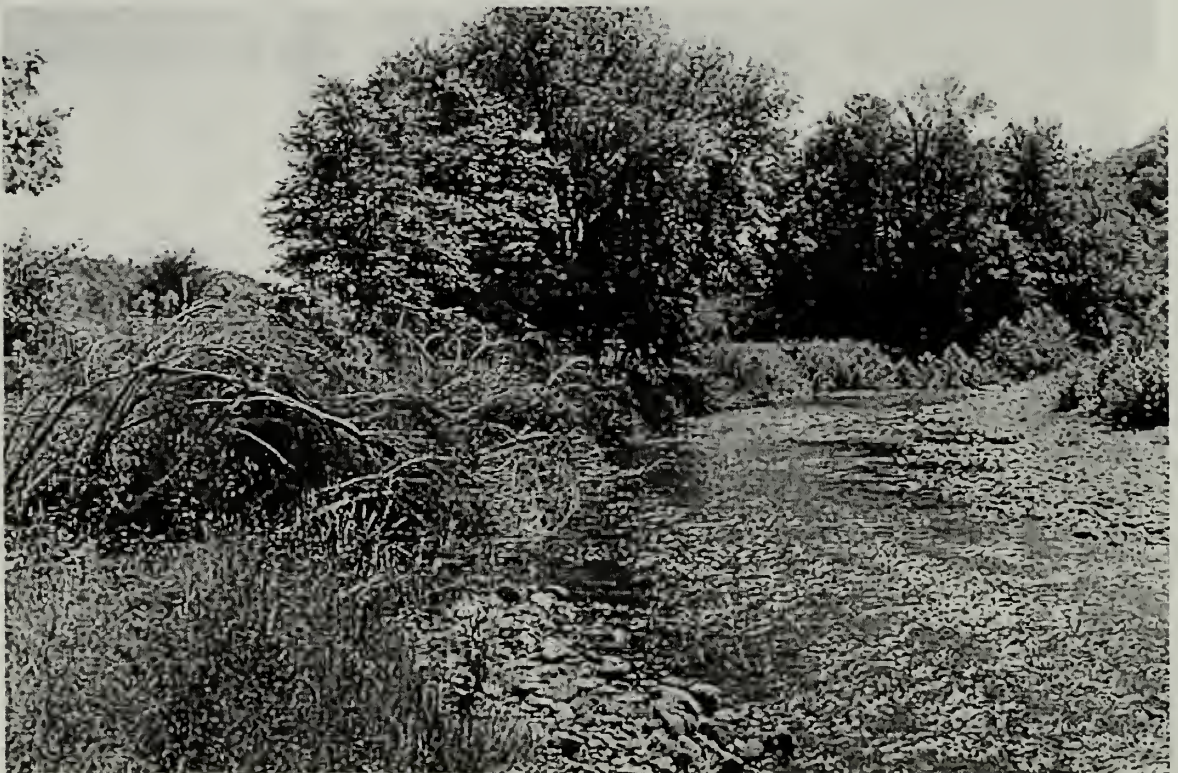
**Photo 10: Downstream view of Ferguson bank (2001)**

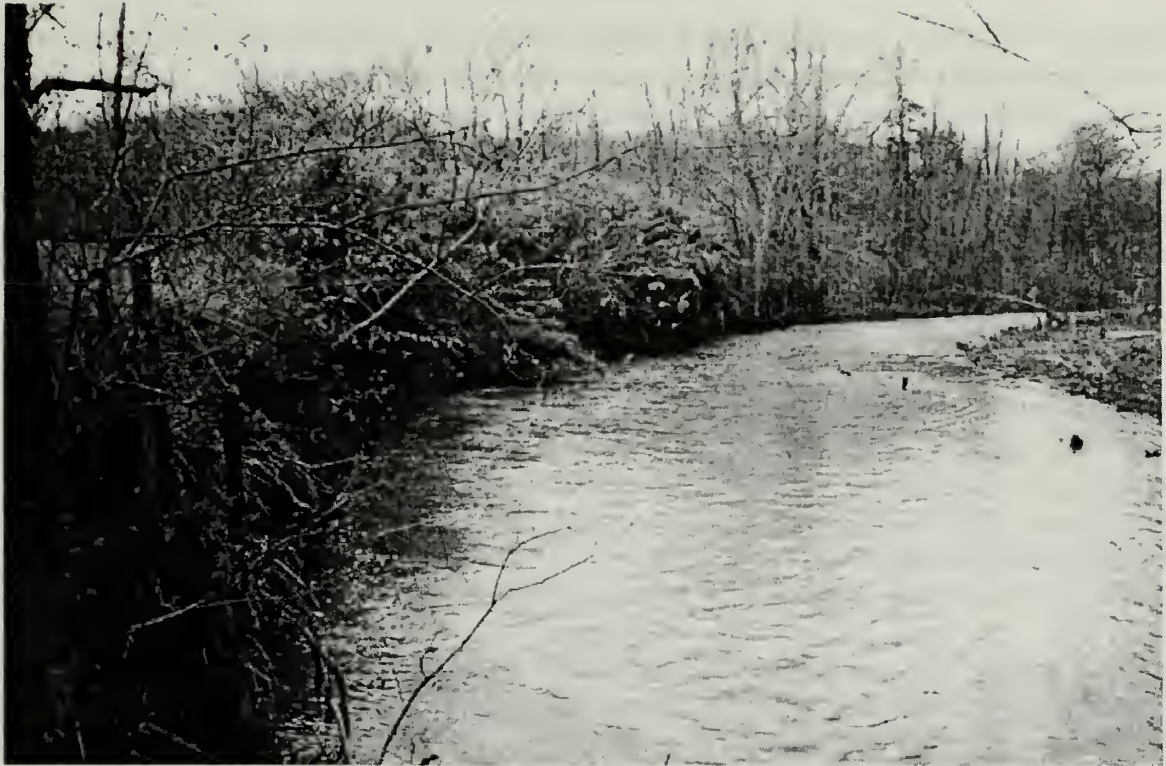
This site is located on Cecil Creek just above its confluence with the Buffalo River. The cutbank at this site is nearly vertical. The opposite side is a well-vegetated channel shelf. The bed is generally cobble that is being brought down from the very steep drainage of upper Cecil Creek. The bank material is mainly clayey silt in the higher portions of the bank and cobble dominates the lower bank. This site is vertically controlled by cobble. The Buffalo River channel provides downstream control. Erosion at this site is due to natural confluence instability and removal of the riparian corridor. The dominant mechanical process appears to be block failure driven by slaking and scour. The eroding bank is between 8 and 10 feet high and 210 feet long. Average lateral migration rate from 1972 to 1992 was approximately 1 foot/year based on the examination of aerial photographs. There was a significant and healthy looking riparian and stream side forested buffer along this reach observed on the 1972 aerial photographs. Because this is a naturally unstable confluence site, this represents an area that would naturally be effected by channel shifts. Unfortunately, the erosion has transgressed into an area where agricultural use has removed all the trees and the erosion can move very rapidly under these conditions.

Photo 12: View upstream of Cecil Creek Confluence Site (1994).

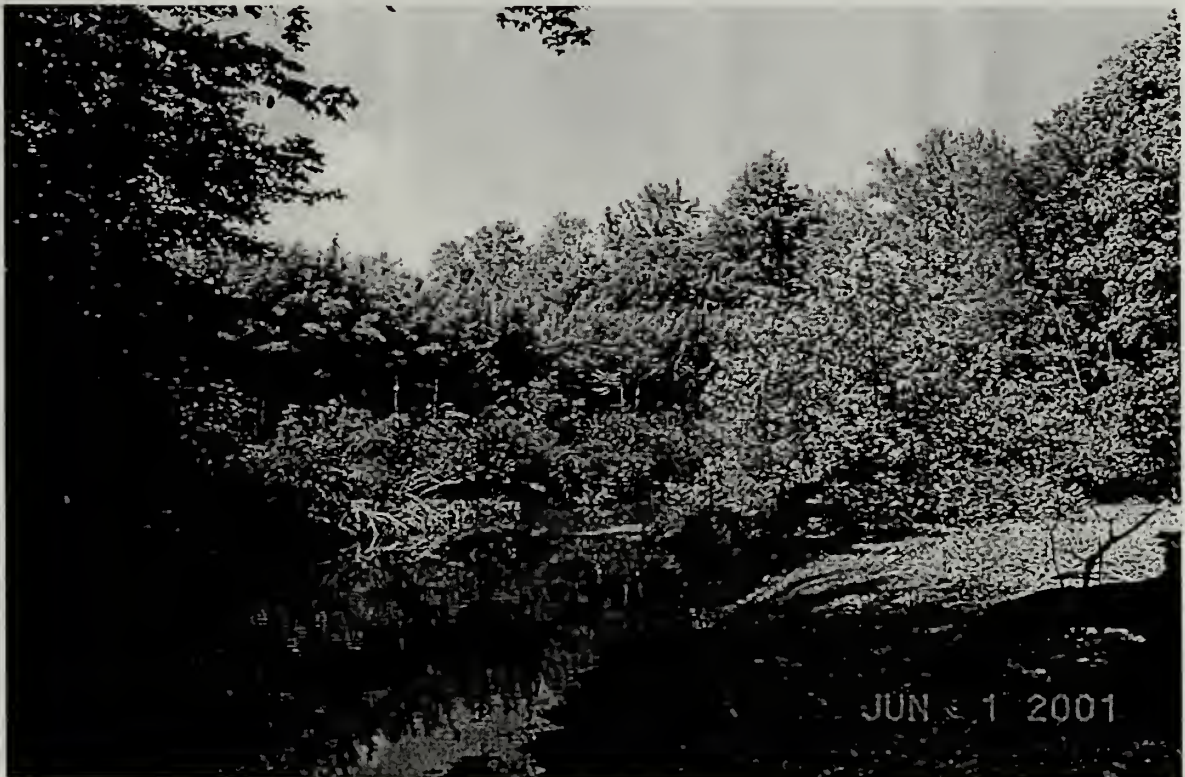
Photo 13: View upstream of Cecil Creek Confluence Site (2001).

**Overall Summary** - This site is stable and no longer eroding. The cedar tree revetment is completely intact and the bank above the revetment is covered with river cane. There is dense river cane growth on top of the bank. The upper row of cedar trees are covered with deposition and the bottom row is 50% covered. There is river cane growing out of the upper row. The thalweg is along the bottom row of cedar trees. The stream channel is deeper and narrower and the point bar across from the bank is becoming populated with sycamore trees.

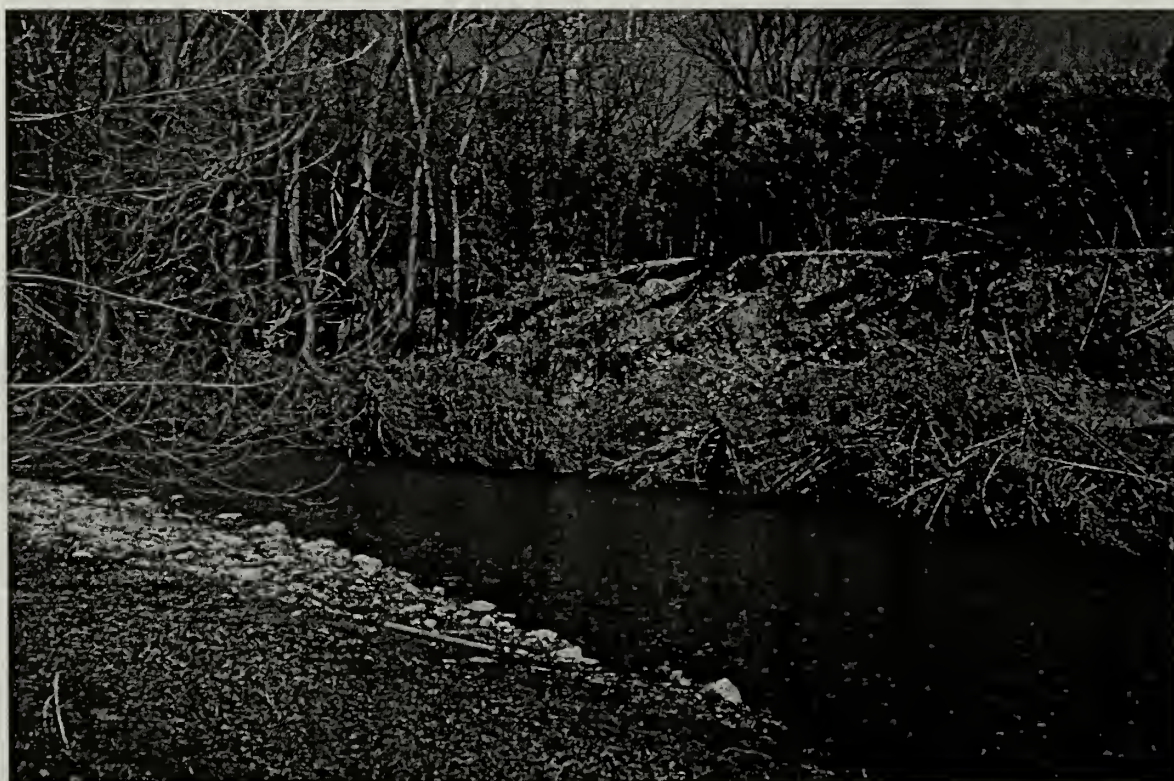
The upper, middle, and lower third portions of the bank are essentially the same. The upper row of cedars is covered with deposition and has river cane growing above it. The bottom row is half covered with deposition and half of it is below the average water level.

**Photo 14: View of Cecil Creek Confluence Site from across stream, after river cane was pulled down on top of the revetment (1995).**

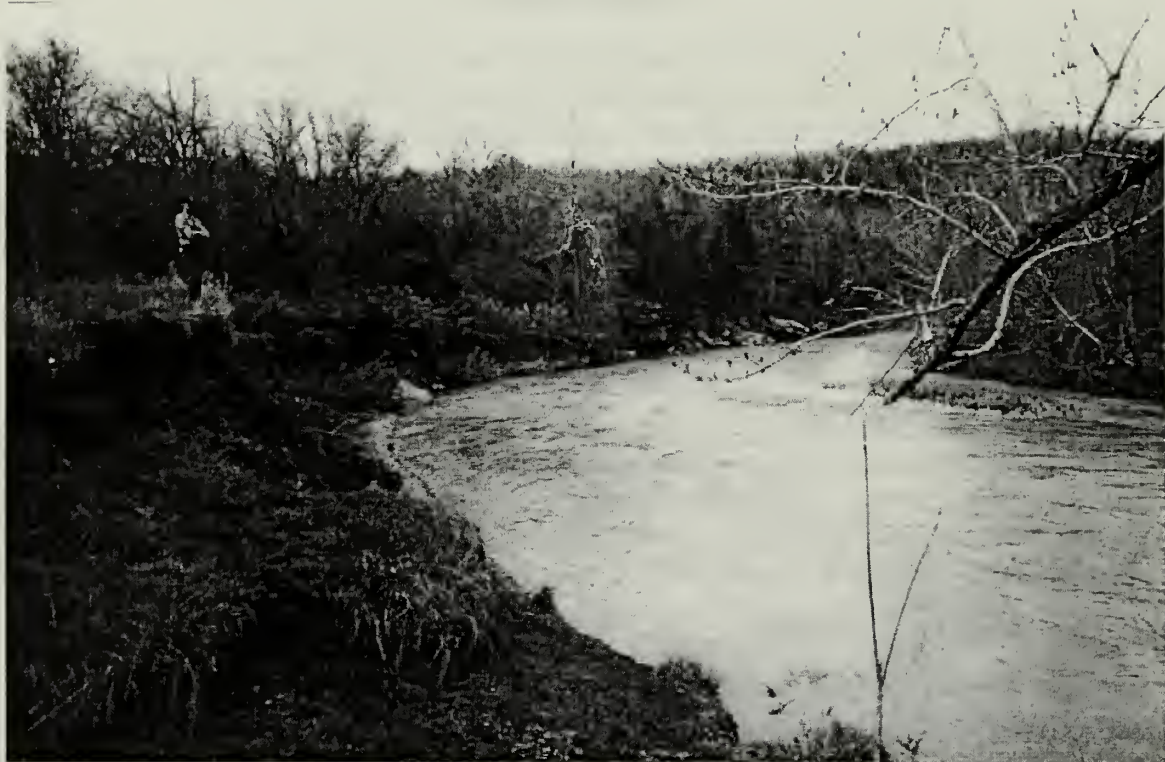
This site is located on the main channel of the Buffalo River. It is a valley crossover reach where the upstream and downstream controls are provided by the bedrock bluffs above and below the crossover reach. The left bank was completely covered by slump scarps along the area that is eroding and is adjacent to an agricultural field. The portion of the eroding bank with remaining riparian buffer (lower end) appears to be suffering mainly from scour below the root zone. The opposite bank has a lower flood plain, but the trees are fairly large indicating that the far side is not aggrading rapidly. The upstream end is beginning to form a more stable geometry. The bed material is dominantly gravel with a lesser component of cobble. Bank height is 20 feet and length to be reveted is 200 feet. The eroding bank extends for another 200 feet below the portion to be back sloped, but has a healthy riparian buffer already established on the top of the bank and large boulders along the toe (Photo 15). Bank material consists of mostly sand with a few feet of gravel and cobbles at the toe. Slump scarps dominate most of the erosion area. There is also evidence of rill erosion on the upper portion of the bank and scour along the lower section. This bank has moved very little in the past 20 years based on aerial photo interpretations. The bank appears devoid of vegetation and the channel configuration is relatively similar on each photo. The rate of erosion is probably less than one foot per year. The riparian corridor has slumped off throughout most of the length of this bank. The buffer below the agricultural field is being impacted by the slumping next to the field because this instability is being propagated downstream.

**Photo 15: View downstream of the lower portion of the Angle Field Site (1994).**

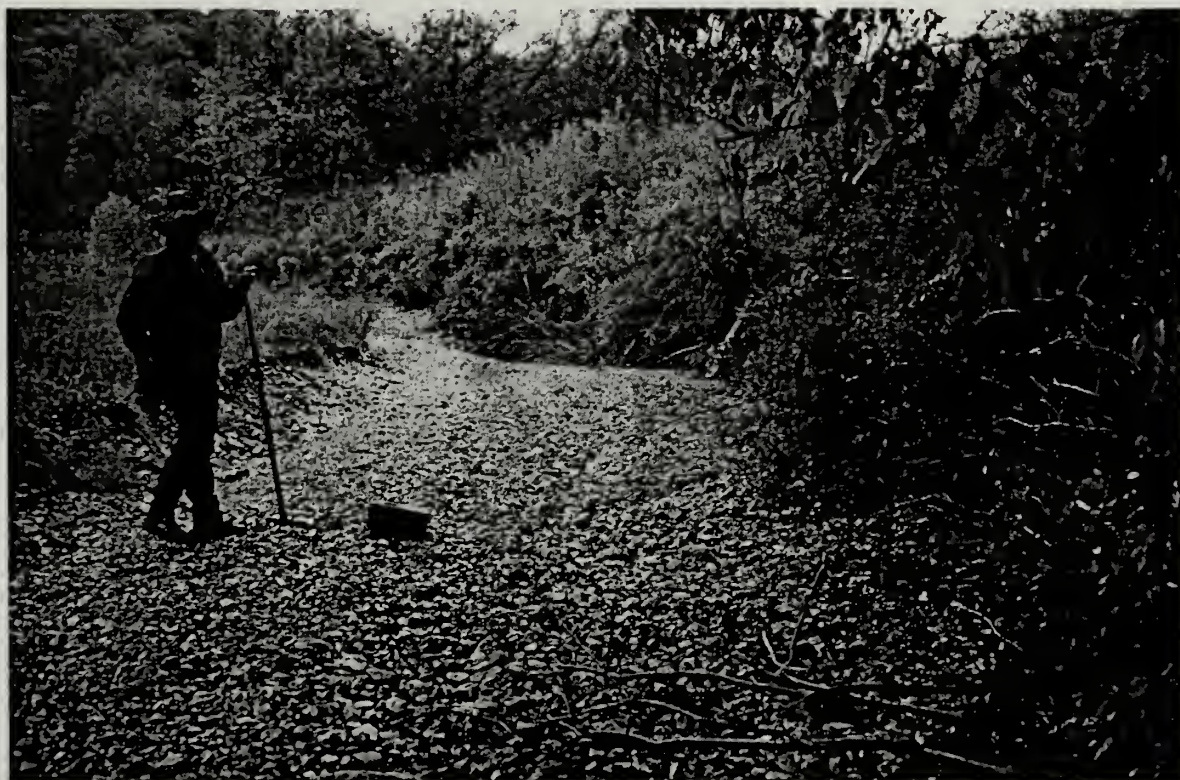
**Photo 18: View downstream of lower Rock Creek Site (2000).**

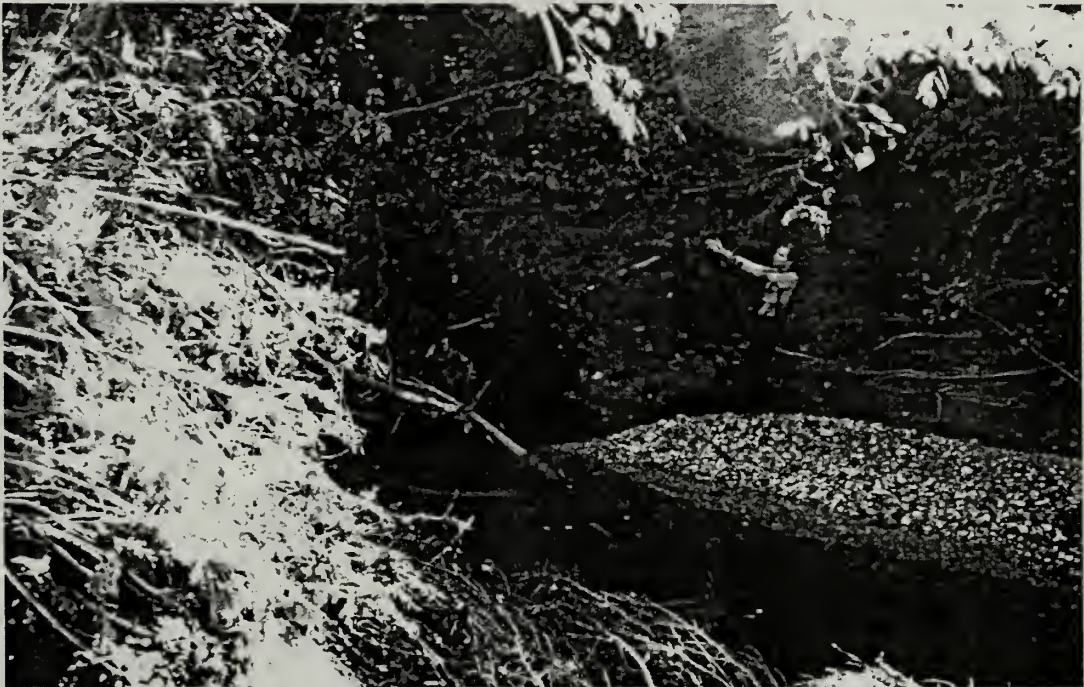
**Photo 19:** Large tree root-wad, uprooted from hillside opposite revetment.  
Person on right is pointing toward root-wad (1997).

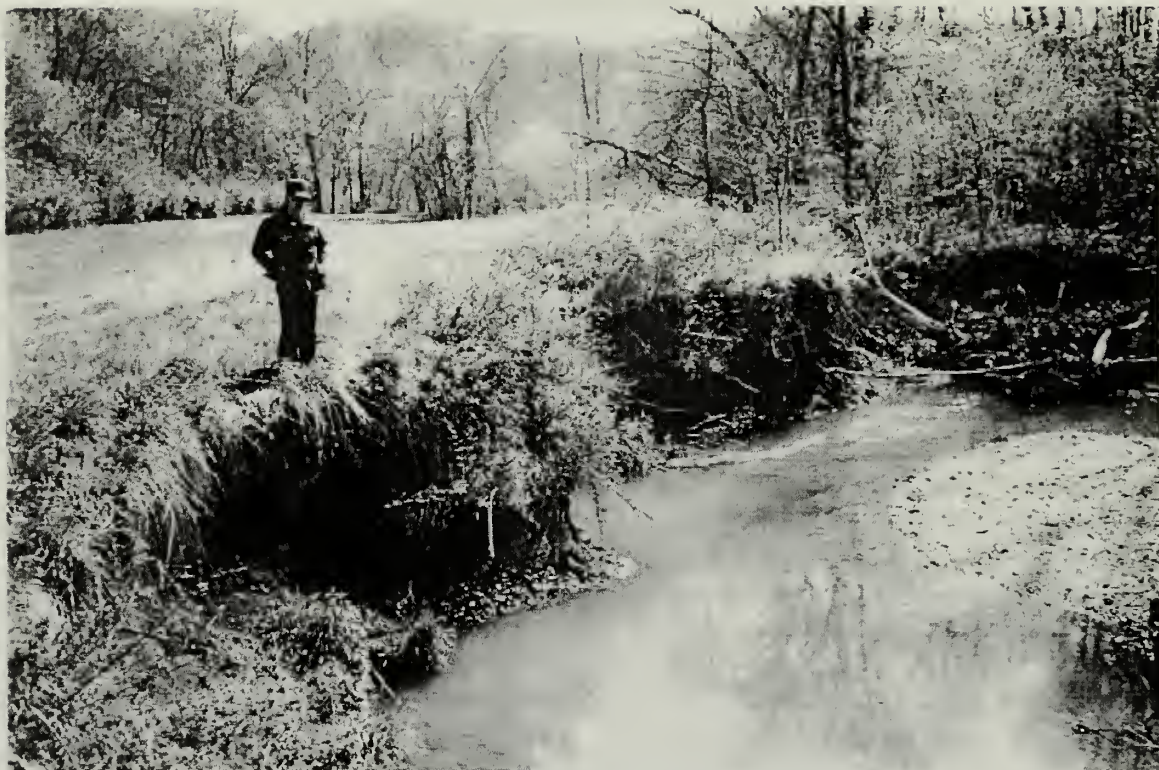
The site is located on Rock Creek approximately 1,500 feet above the confluence with the Buffalo River. The bank top has been cleared for agricultural use. The eroding bank at the project site is about 6 feet tall and 155 feet long. The channel consists of rough and undulating cut bank on the erosion side and slipoff slope and fresh gravel on the opposite aggrading side. The bed material is dominantly gravel, intermixed with cobble in places. The bank is clay/silt with some sand. The lower portion is dominated by gravel with some rocks interspersed throughout the bank. There are also some resistant clay outcrops near the bottom which stick out into the stream along the eroding bank. The riparian corridor is thin throughout the length of the stream as it runs along the agricultural use field. At the eroding bank the thin wooded buffer has been breached leaving only unconsolidated sediments to counter the erosional forces. The creek is against a bluff line on the far side both above and below the site providing upstream/downstream control. The dominant erosion processes are scour and slaking along the bank, which set up conditions for subsequent block failure. The erosion rate is estimated to be approximately one foot per year as determined from the 1972 and 1992 aerial photographs.

Photo 20: View downstream of Upper Rock Creek Site (1994).

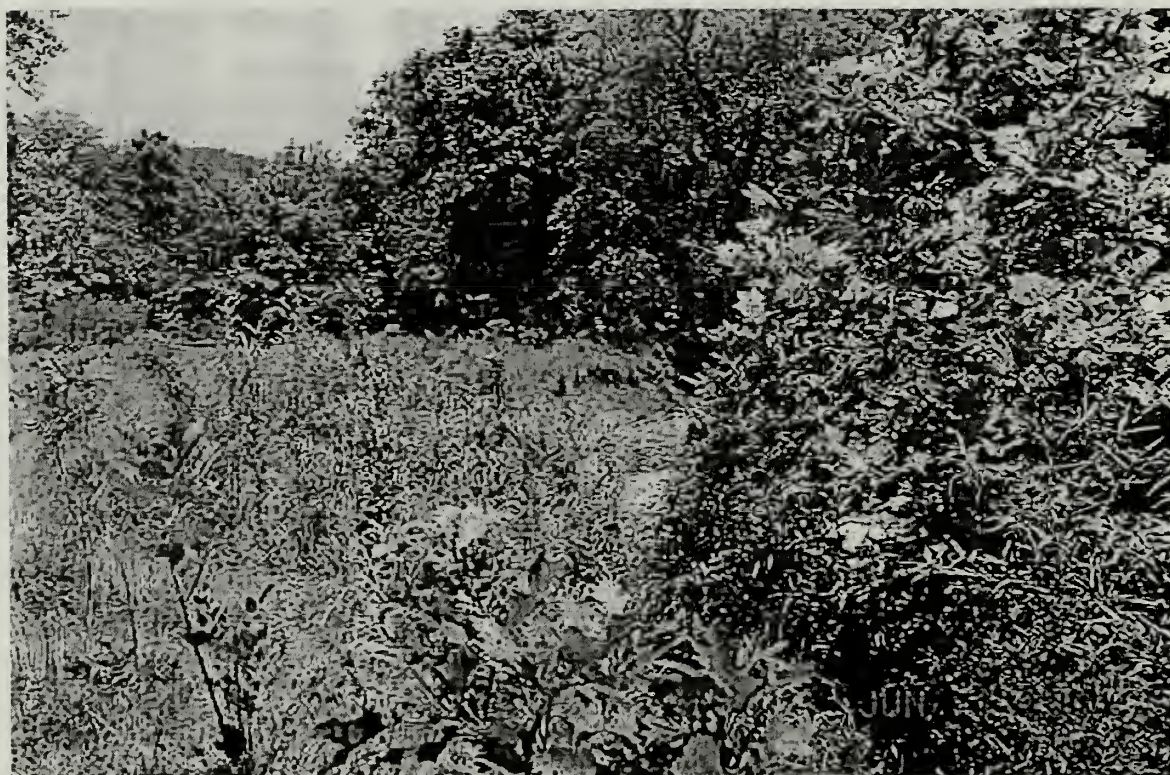
Photo 21: View downstream of Upper Rock Creek Site (2000).

**Overall Summary** – This project has successfully slowed erosion at the site however some erosion is still occurring on the lower portion of the bank. The bank is stable and the upstream two-thirds supports dense river cane growth above the revetment. The downstream one-third has an exposed vertical face with very little vegetation. The thalweg is along the bottom of the cedar tree revetment on the down stream portion and has eroded out behind a twenty foot section of the revetment forming a small pool. The riparian corridor and the majority of the bank have begun to revegetate and there is good deposition in most of the revetment holding the bank slope to 1:1. Part of the reason for the loss of the lower end of this revetment is the result of an unusual circumstance. In 1997 a huge (4' DBH) sweet gum tree was uprooted from the hillside opposite the revetment and slid down into the creek (Photo 19). The root wad was so large as to nearly block the entire channel. Because this was a natural event we did not attempt to remove the log or root wad and waited to see if the tree would be floated out or the creek cut around the obstruction. As it turns out both things happened and a portion of the revetment was lost in the process. However, it appears that this bank is well on its way to returning to its natural trend of inherent stability, which is the goal.

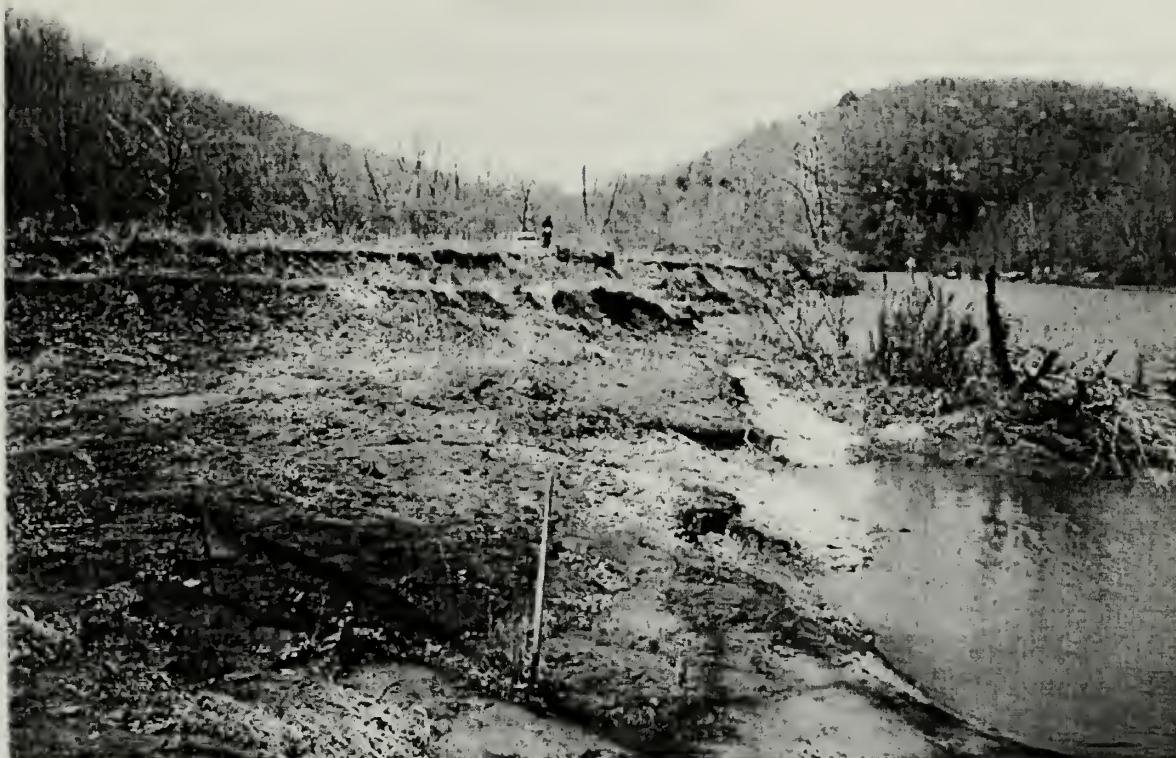
This bank is located on the main channel of the Buffalo River just down-stream from the mouth of Sheldon Branch (see map in Appendix B). The eroding bank is at the upstream end of the main channel overbank flow line, where flow from the channel enters the floodplain. Flow exiting the river channel is eroding the bank, which is weakened by a lack of riparian trees. The absence of hydraulic roughness allows high over bank flow velocities, which also contribute to the instability. The channel appears to become narrower at the lower end as it approaches the bedrock bluff near the downstream terminus of the eroding bank. This combined with the retreat of the bank and widening of the channel results in the aggradation of sediment in the channel and the formation of a mid-channel island. The bars form as the bank erodes, and bars become more resistant to erosion because they revegetate with dense willows. The eroding bank is very rough, with scalloping and shelving controlled by differential resistance of the various alluvial layers. The bank height is approximately 12 feet and it is 420 feet in length. Bank slope ranges from gentle to nearly vertical. The bed is composed of gravel with interspersed cobbles. The bank is composed of a mix of stratified sandy silt with some clay. A cobble layer is visible near the toe. Some strata are almost pure sand. There is bedrock lateral control immediately upstream and downstream of the reach. Vertical control is not immediately apparent. Bank retreat from 1972-1992 aerials is 5-10 feet/year. No ground monitoring has been performed at this site. A thin riparian buffer can be observed on the 1972 aerials. These trees were probably lost to slumping as described above.

**Photo 22: View upstream of the Sheldon Branch Site (1994).**

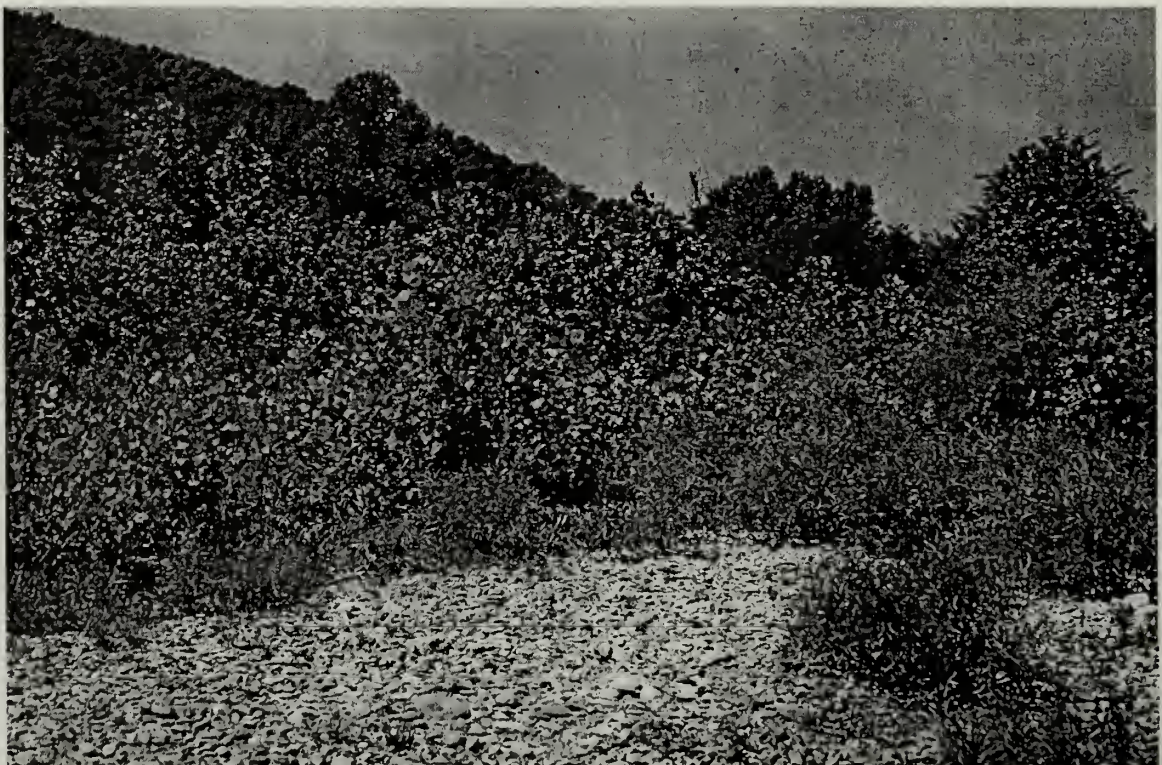
Overall Summary – Restoration and stabilization efforts at this site have been one hundred percent successful. The bank above the revetment, the revetment area, and the area between the revetment and stream are completely covered with native trees, river cane, and dense annual vegetation. Both rows of the cedar tree revetment are completely covered with deposition. The native seedling and rhizome planting efforts have been successful. Mature river cane and two to three inch trees are growing on the entire bank. The bank has held at a one to one slope. The stream channel has moved out well away from the bank and a lateral bar is beginning to form and revegetate between the stream and project area. The only problem at this site has been with the replanting of the riparian corridor. Heavy elk use in this area of the river has resulted in a higher than normal seedling mortality rate.

**Photo 24: Close-up view of vegetation at Sheldon Branch Site (2001).**

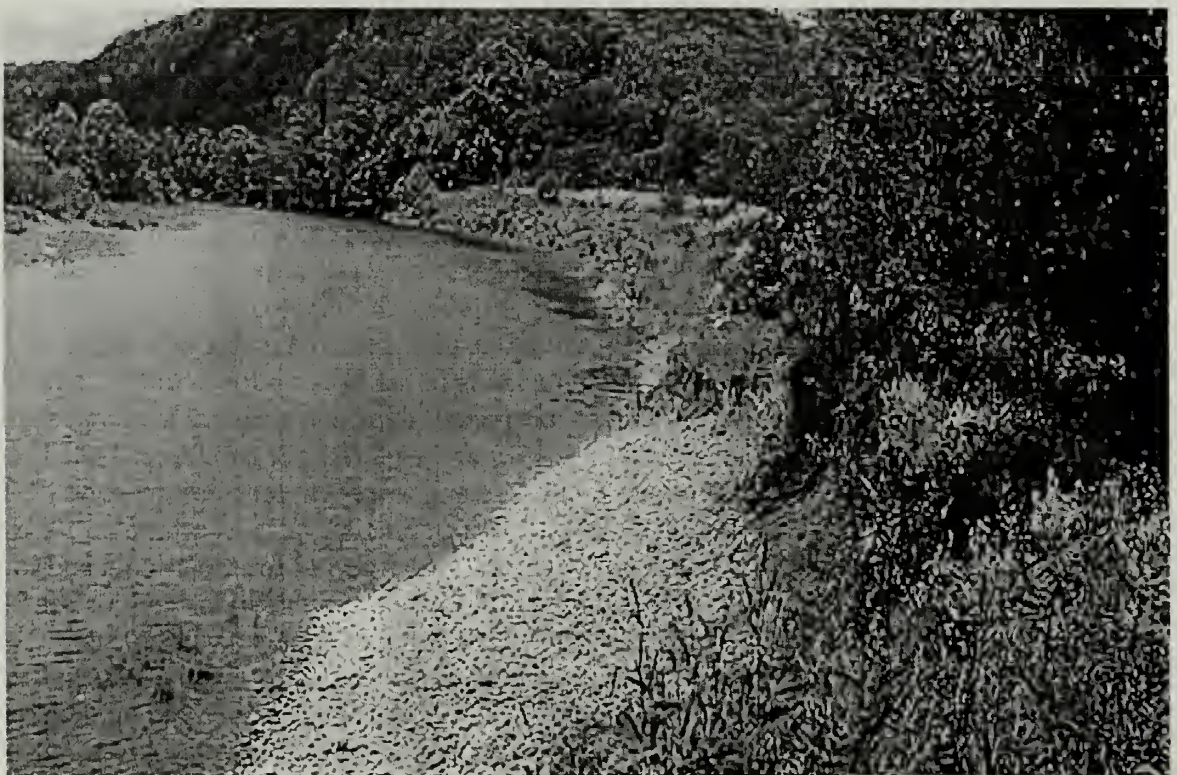
**Photo 26: Upstream of upper portion of the Jamison Creek Site (2001).**

Overall Summary – Stabilization and restoration techniques used at this site have been successful. Native hardwoods, sycamore trees, willows and annual vegetation are growing on the bank slope within and above the cedar tree revetment. The water is significantly deeper in front of the revetment. The double row revetment is below the water level the majority of the time and the cedar trees are partially filled with deposition. There is an exposed vertical bank at the downstream end of the revetment where a small portion of the bank has eroded away behind the revetment. The revetment appears to be well anchored and holding the stream away from the bank.

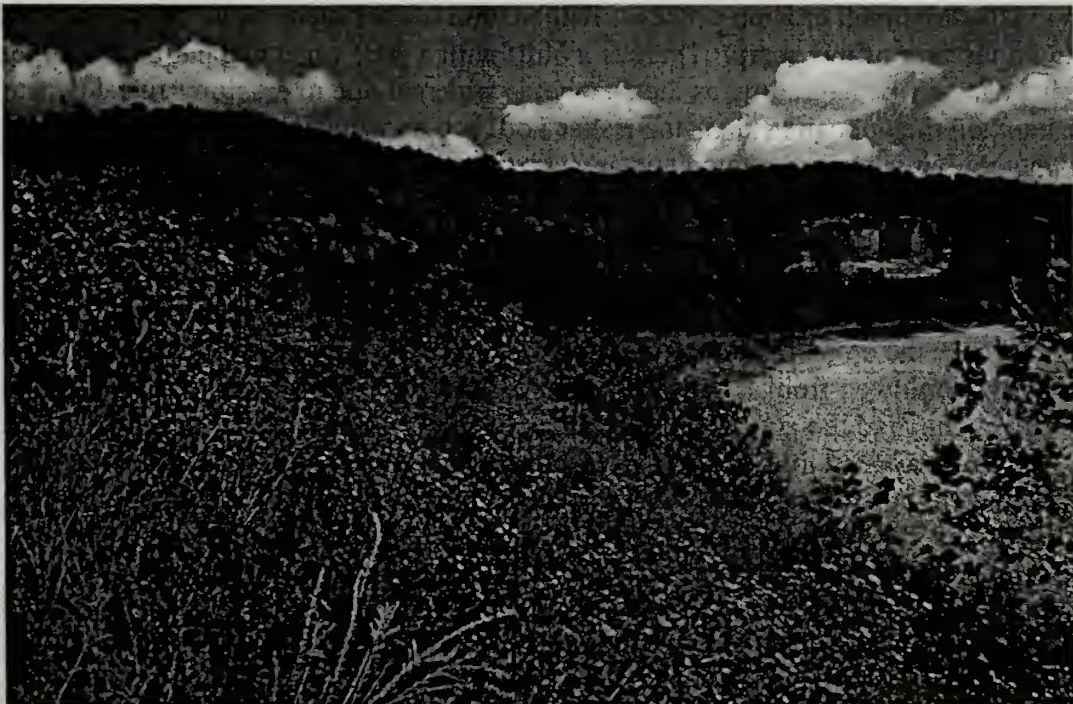
**Photo 27: View looking downstream at Jamison Creek Site (2001)**
